NTSB

Illustrated Digest

Norfolk Southern Railway Derailment and Subsequent Hazardous Materials Release

East Palestine, Ohio • February 3, 2023

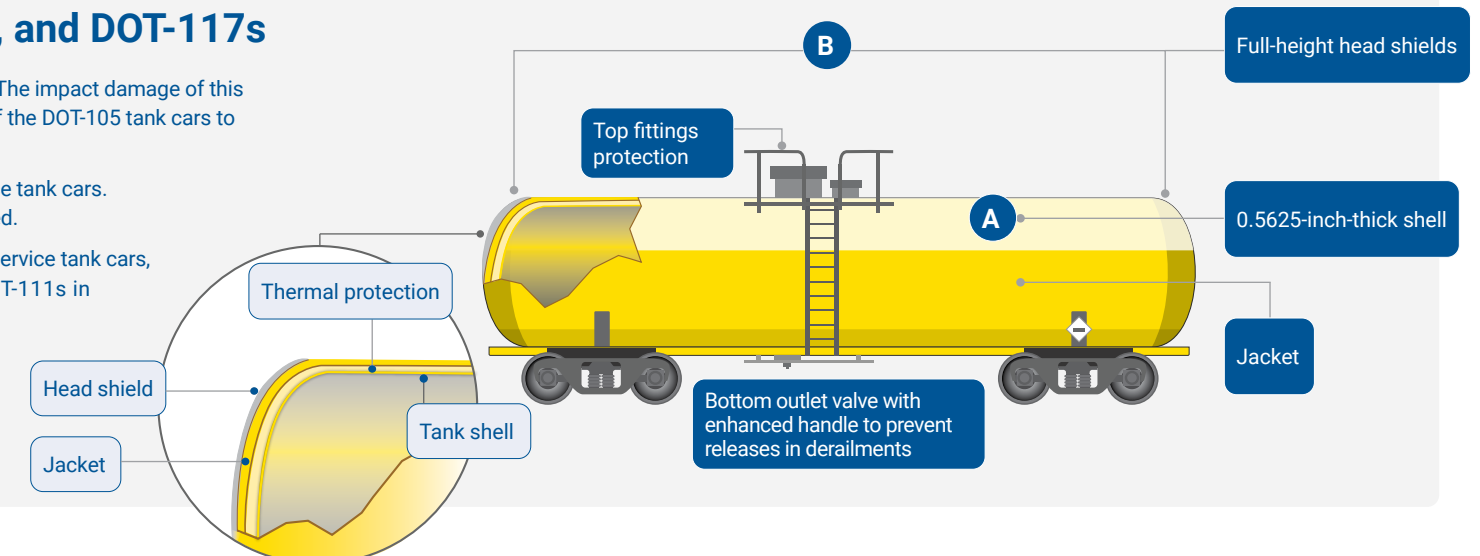
DOT-105s are tough, pressure tank cars. The impact damage of this derailment did not challenge the ability of the DOT-105 tank cars to contain their cargo.

DOT-117s are also nonpressure general service tank cars, but offer improved survivability over DOT-111s in derailments and fire conditions.

DOT-117 tank cars must meet the same thermal survivability performance requirements as pressure tank cars, such as DOT-105s.

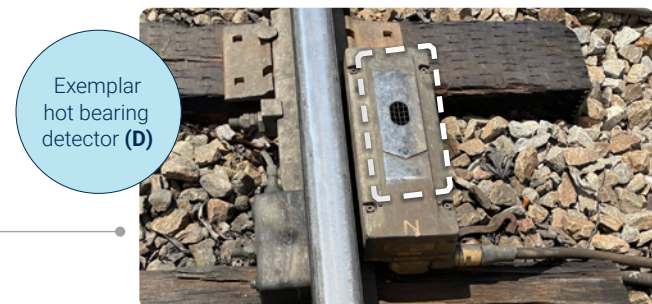
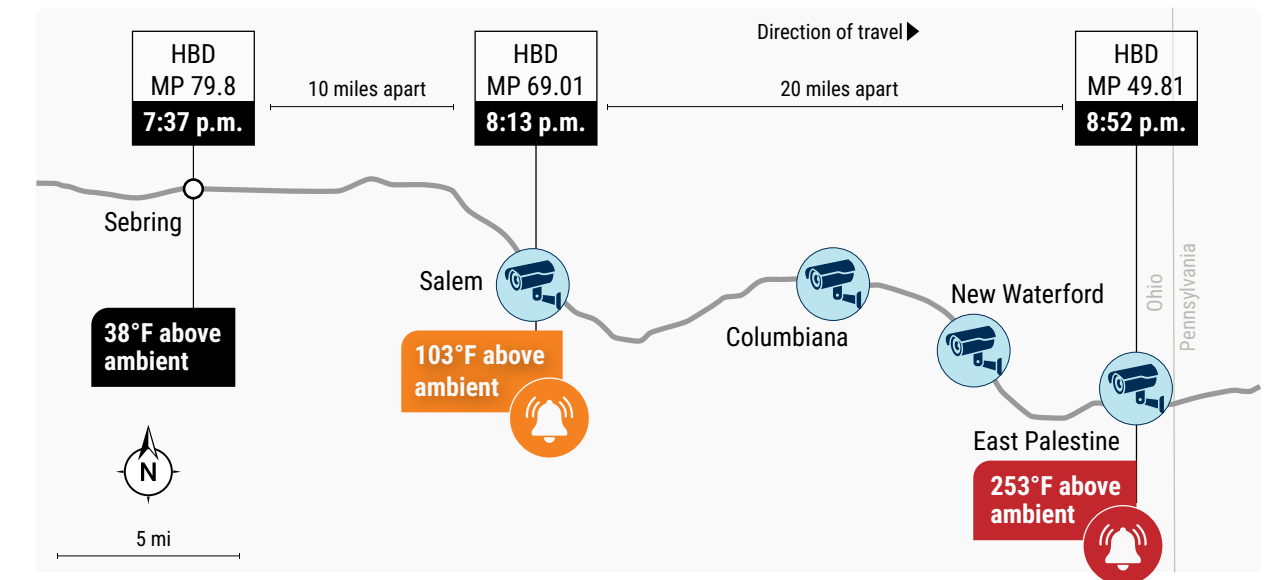
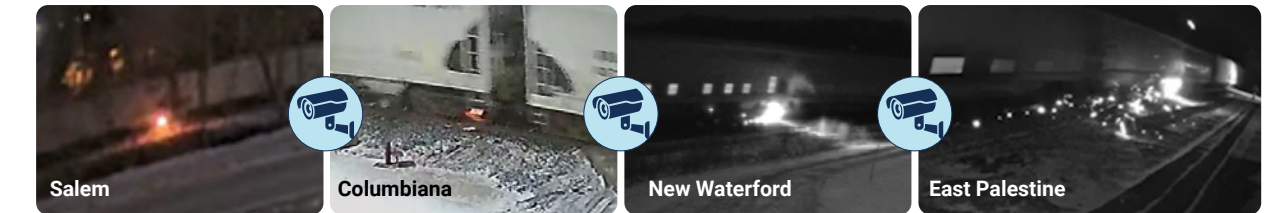
At 8:13 p.m., at the Salem HBD, the reading for the L1 bearing was 103°F above ambient. This reading was high enough to trigger a noncritical alert to the Wayside Help Desk (see box), but not to the crew. A surveillance camera picture from Salem showed fire near the bearing (right). Surveillance cameras in Sebring also captured images of the train, and no anomalies were noted.

Under NS rules, if a train's crew hears a critical alarm, they must stop the train right away and inspect the wheelset that triggered the alarm. The engineer began to slow the train before 8:54 p.m.

But it was too late; the hopper car and 37 others derailed as the train's emergency braking system activated.

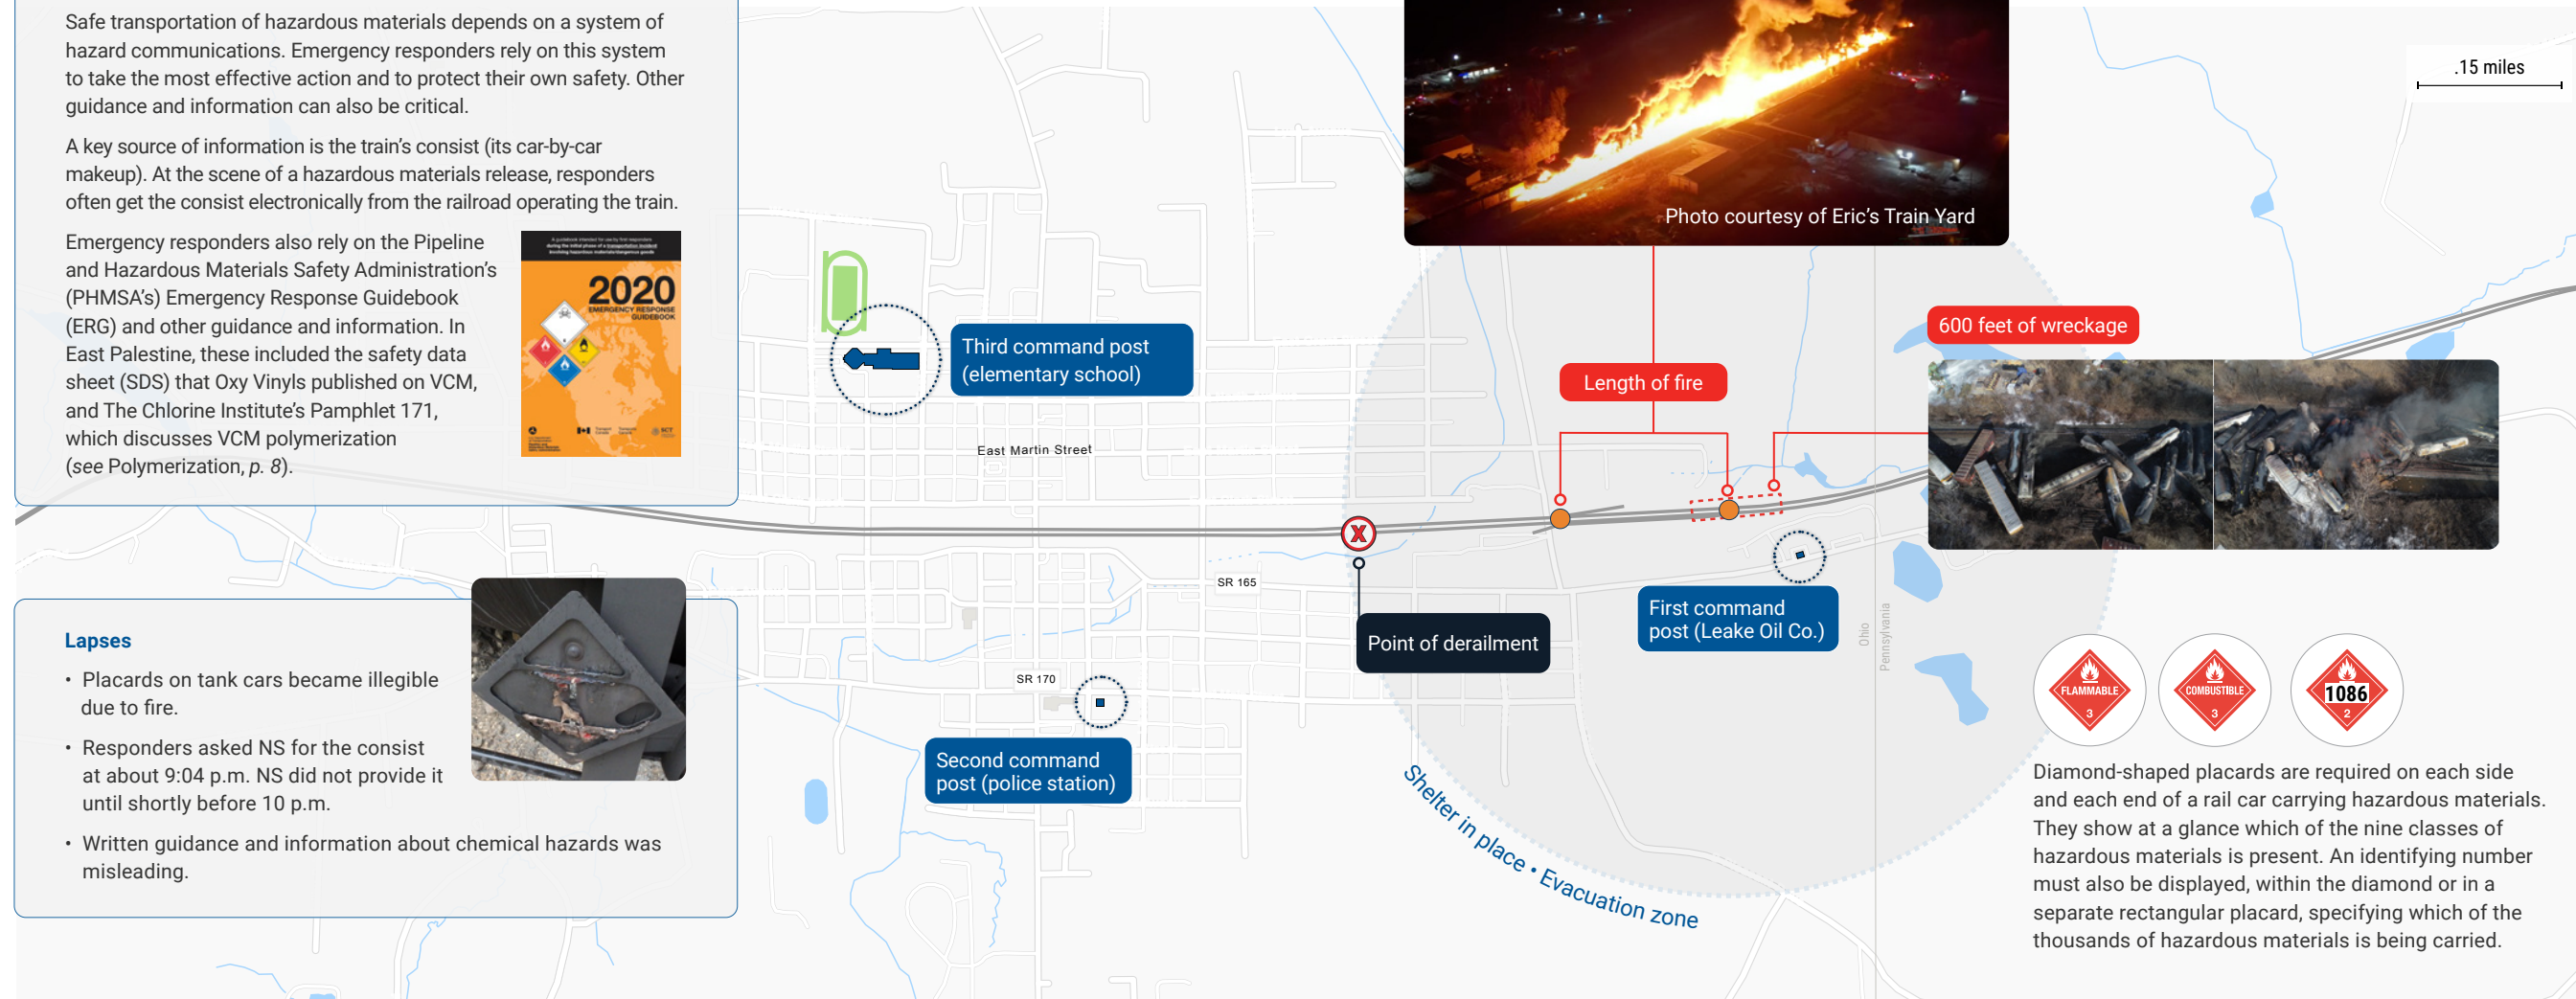
- Placards on tank cars became illegible due to fire.
- Responders asked NS for the consist at about 9:04 p.m. NS did not provide it until shortly before 10 p.m.
- Written guidance and information about chemical hazards was misleading.

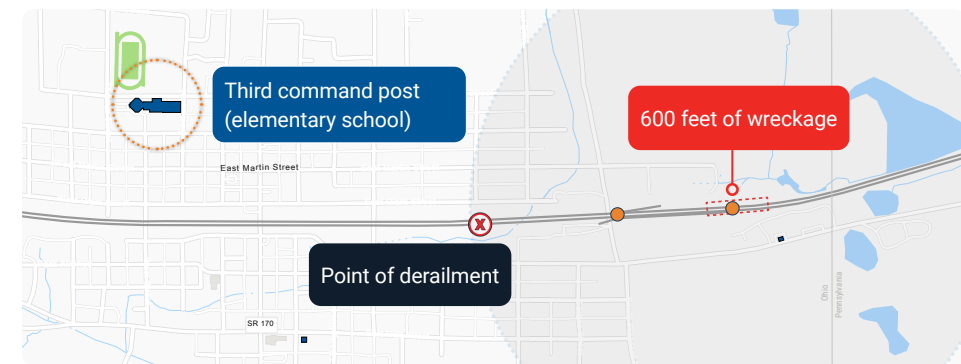
What happened to each derailed car

At right, you can see the fate of the derailed cars. All of the DOT-117 (yellow, black labels) tank cars resisted damage and did not spill their contents. Three DOT-111 tank cars (A-C) did release their flammable and combustible contents through punctures and/or cracks from the derailment, releasing flammable or combustible liquids.

Five DOT-105 cars carrying VCM (D-H) survived the derailment without punctures or tears but contractors vented and burned their contents 3 days later. Four of them had withstood fires without cracks or punctures, even though their PRDs activated and vented some contents.

The initial 2- to 3-hour pool fire that burns in the ditch alongside the derailment is likely fueled by butyl acrylates from tank car (A) in the diagram. Other candidates include the two other red tank cars in the diagram, which carry combustible liquids (B and C).

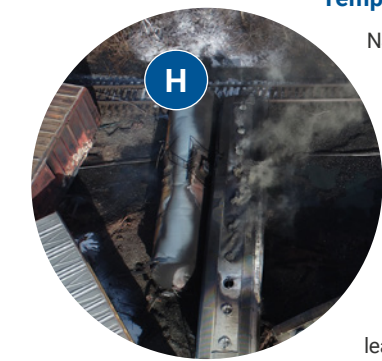
Temperature and pressure in the VCM cars

NS contractors tried to measure the VCM cars' internal pressures on February 4 and 5, but could not measure the pressure of cars exposed to pool fires. The pressure in the car that was not exposed to pool fires was stable. None of the tank cars was releasing VCM except through PRDs.

Also on February 4 and 5, NS contractors noted no signs of gas being released from the car that was resting against the burning hopper car (H), though a gas detector indicated the presence of volatile compounds near the top of the car. SPSI's president believed that VCM was leaking from this car, but that polymerization inside the car was preventing it from releasing at large enough quantities to catch fire.

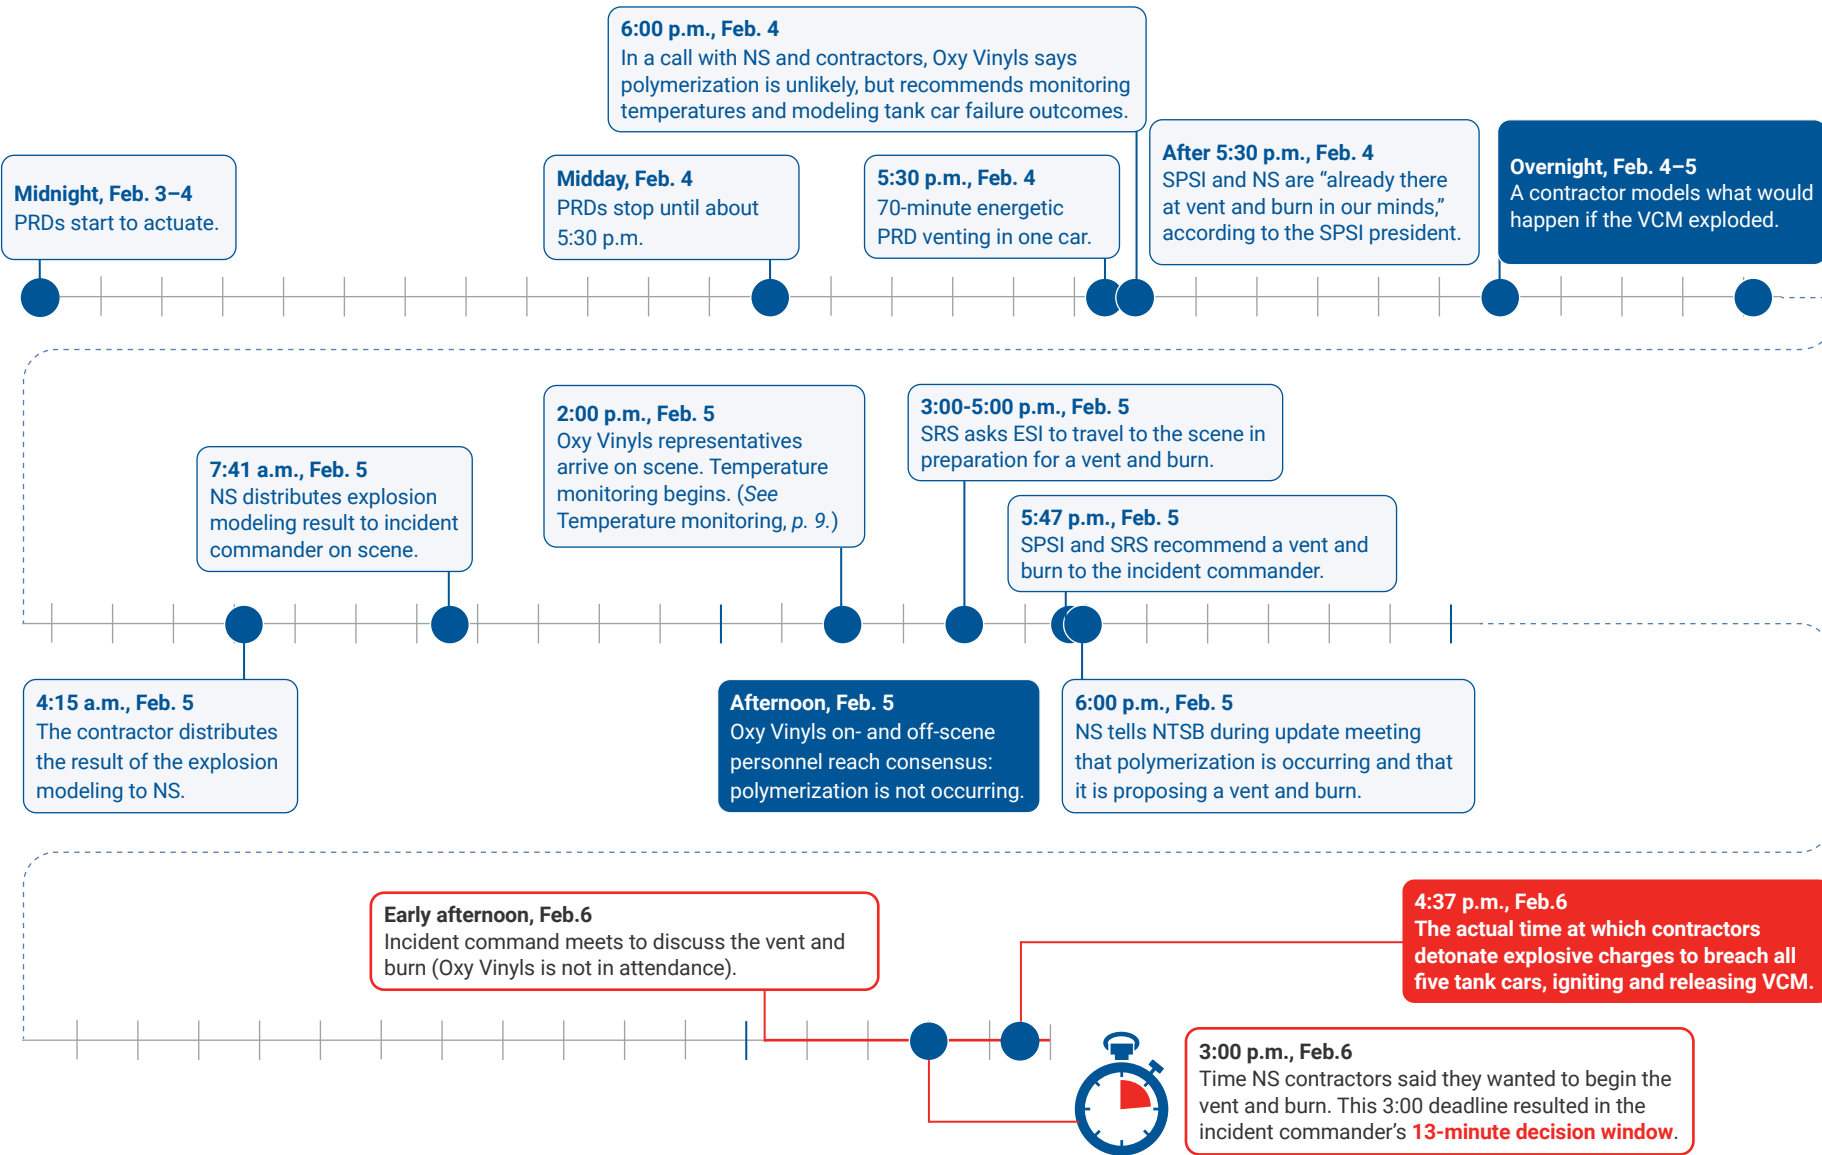
The vent and burn decision

NS and its contractors advocated for a vent and burn to prevent an explosion caused by polymerization. Oxy Vinyls said polymerization was not occurring. On February 6, the incident commander was given **13 minutes to decide what to do**, but was only presented with one viewpoint.

On scene, NS and its contractors relied on guidance that included misleading information about signs of polymerization. (See Hazard communication and guidance, p.6, What is polymerization?, p. 8.)

Shortly after midnight February 3-4, PRDs on the VCM tank cars began to actuate (see Pressure relief devices, p. 7), then vented material on and off until the next afternoon. At first, NS and its contractors considered flaring and hot tapping to remove the contents of the intact VCM cars (see Alternatives to vent and burn, p. 12).

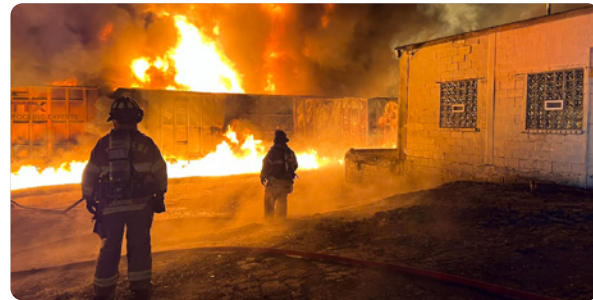
Problems with wayside detectors

In this derailment, although the bearing was on fire, the Salem HBD sent a noncritical alert that did not reach the crew. An alarm only sounded nearly 39 minutes later, and more than 20 miles away, in East Palestine. Because of design constraints, HBDs are likely to indicate misleadingly low bearing temperatures. In addition, the distance between HBDs varies, as do companies' standard operating procedures related to crew alert and alarm responses. Wayside detectors, like HBDs, vary in configuration, maintenance, and alarm criteria, and minimum universal standards don't exist. This makes it impossible to standardize crew responses to hot bearing alarms and can make it so a train crew doesn't have enough time to respond.

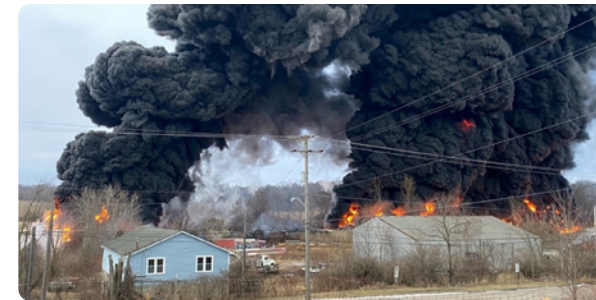
Vent and burn decision

The Chlorine Institute's Pamphlet 171 overstates the probability of VCM polymerization where tank cars remain intact. NS and its contractors who consulted Pamphlet 171 on scene overestimated the likelihood of polymerization. Additionally, NS and its contractors continued to describe polymerization as an imminent threat when expert opinions and available evidence should have led them to reconsider their course of action—on-scene temperature trends did not indicate that a polymerization reaction was occurring, which was confirmed by postaccident examinations. NS compromised the integrity of the decision to vent and burn the tank cars by not communicating expertise and dissenting opinions to the incident commander making the final decision.
