September 11, 2024

MIR-24-27

Barge Breakaway from *Nell Womack* Tow and Contact with Dock

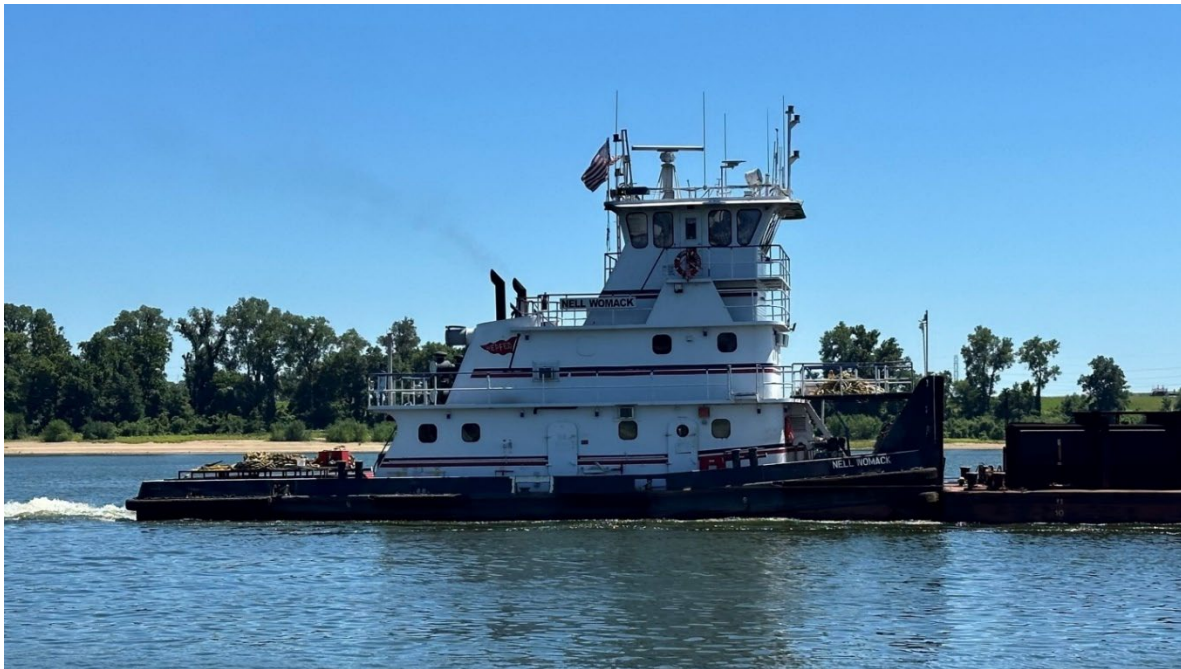
Figure 1. *Nell Womack* on unknown date before the contact. (Source: Wepfer Marine)

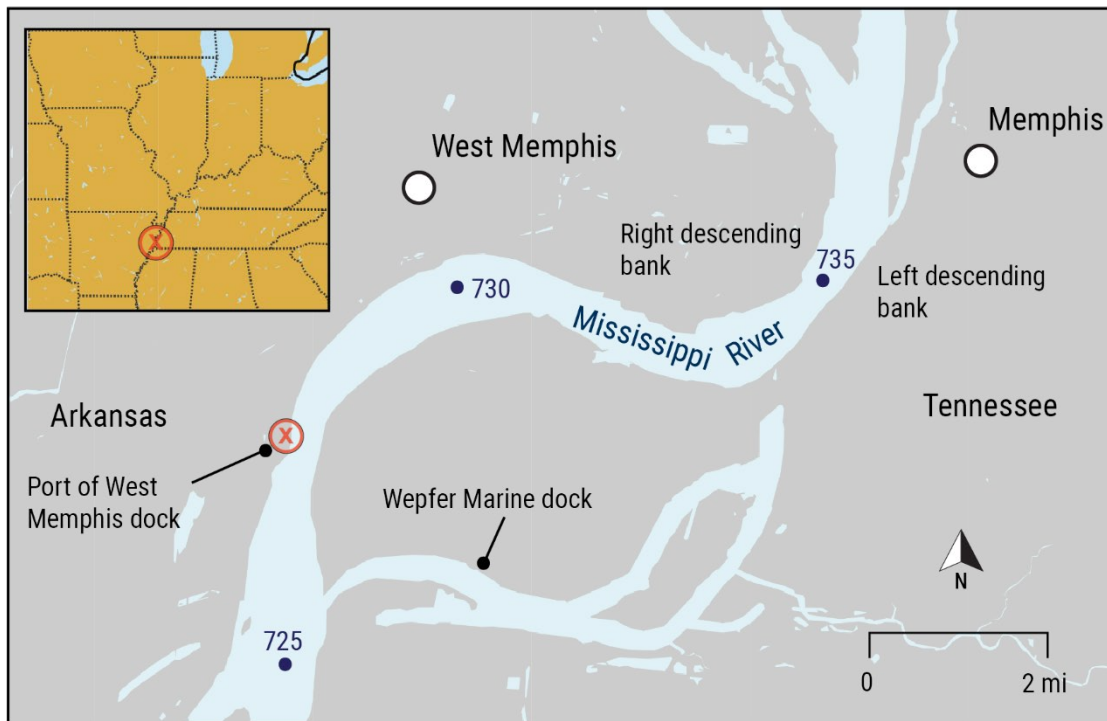
Figure 2. Area where the barge ACBL2549 contacted the Port of West Memphis dock, as indicated by a circled X. (Background source: Google Maps)
