REPORT OF INVESTIGATION

Fatal Machinery Accident
May 16, 2024

Cornerstone Labor Services, Inc. (B4839)
Ashland, Hanover County, Virginia

Coal Mountain No 1 Surface
CM Energy Operations LP
Coal Mountain, Wyoming County, West Virginia
ID No. 46-09062

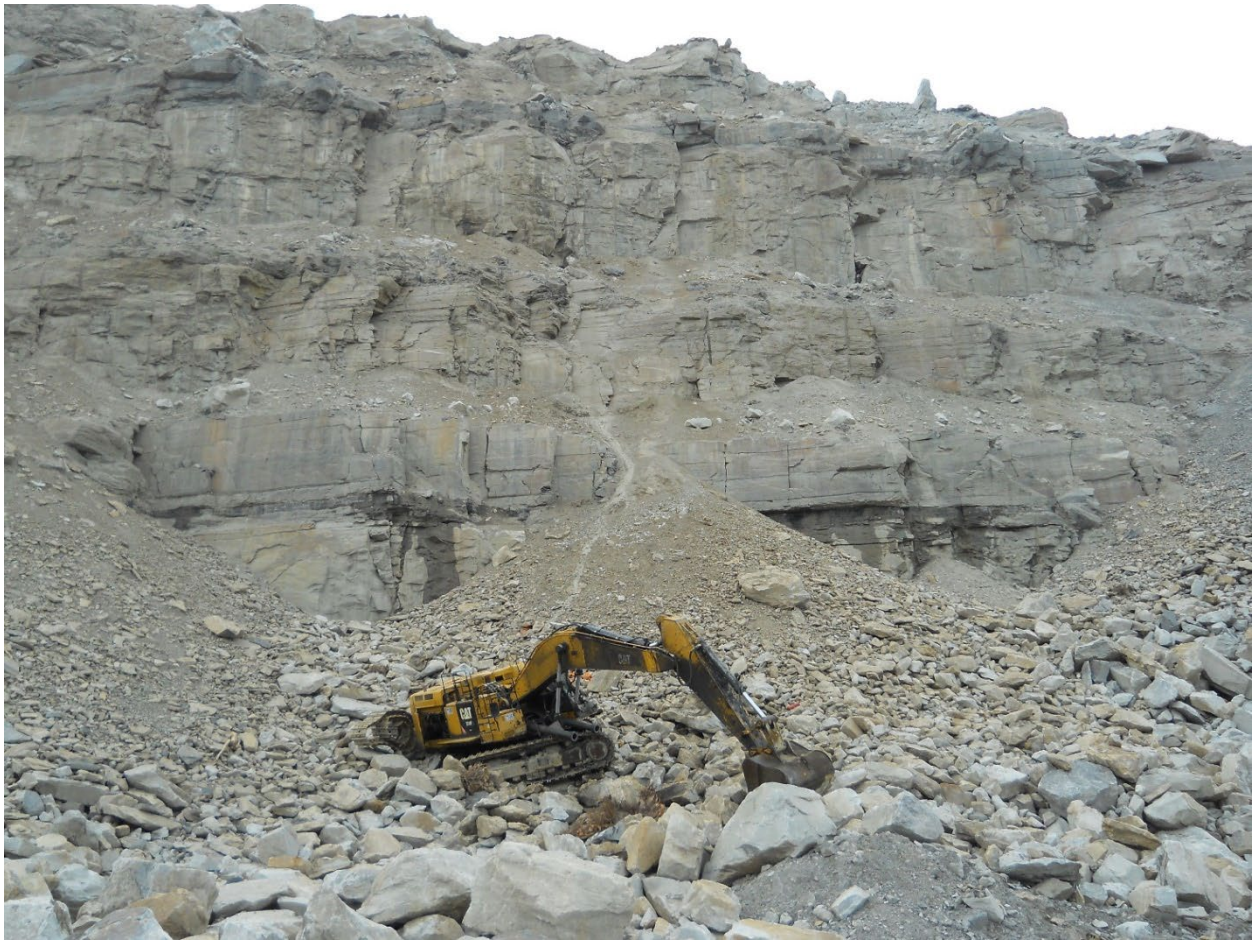
On May 16, 2024, at approximately 2:15 a.m., Virgil Paynter, a 59 year-old contract excavator operator with ten weeks of mining experience, died after the excavator he was operating traveled over a highwall and fell 235 feet before coming to rest on top of spoil material in the pit below. Paynter was ejected from the operator's cab during the fall.
