**TRANSPORTATION SAFETY BOARD OF CANADA
ANNUAL REPORT TO PARLIAMENT 2023–2024**

Annual Report to Parliament 2023–24

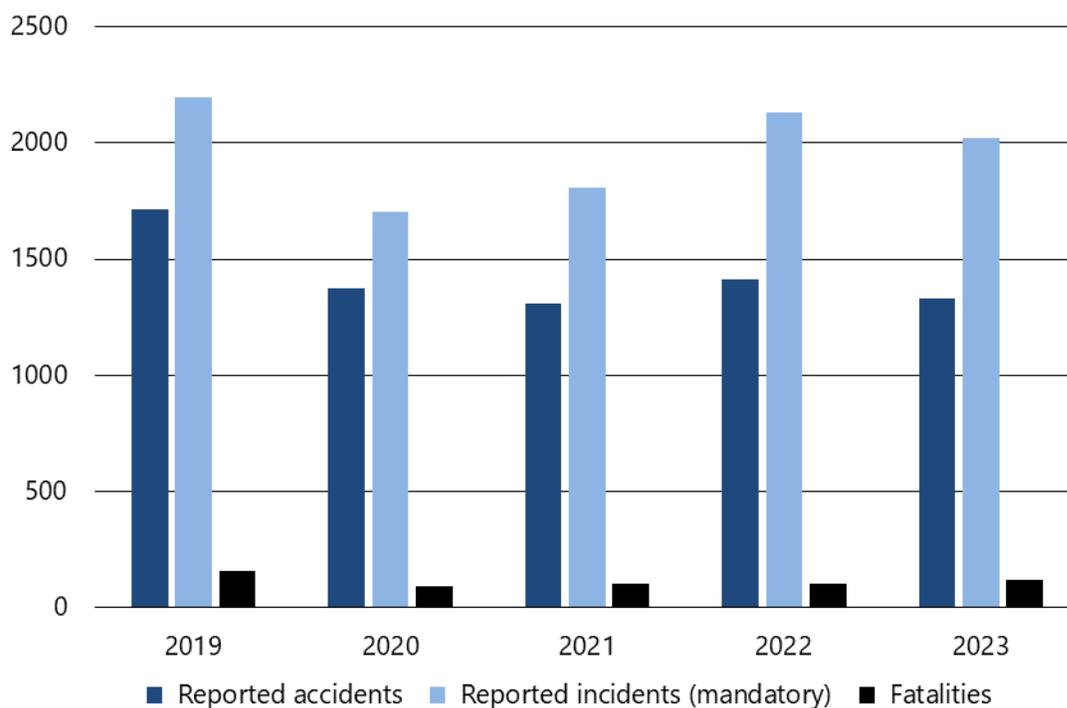
The total number of occurrences [reported to the TSB](#) (as required under the *Transportation Safety Board Regulations*) in the 2023 calendar year (3350) was 6% lower than the 3556 occurrences reported in 2022 (Figure 1).

Figure 1. Transportation occurrences reported to the TSB, 2019 to 2023

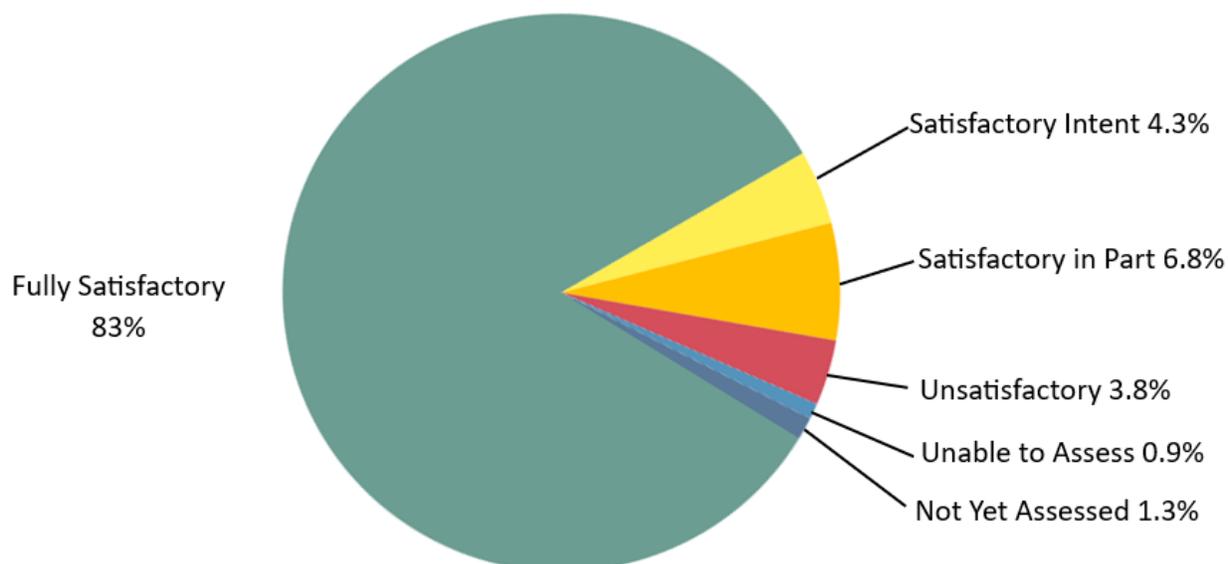
Since 1990, the Board has made 634 recommendations. By the end of 2023–24, it had given 83% of the responses to these recommendations the [highest rating of Fully Satisfactory](#). This means that stakeholders, including Transport Canada, have taken action to substantially reduce or eliminate the safety deficiencies the Board has identified (Figure 2).

Figure 2. Board assessments of responses to recommendations from 29 March 1990 to 31 March 2024

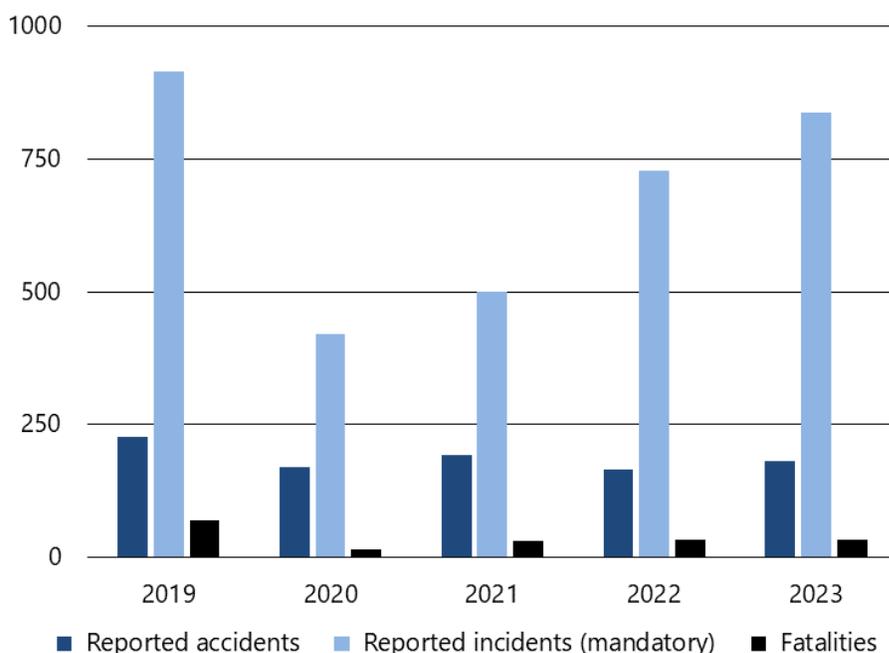
The Transportation Safety Board of Canada (TSB) received 1020 reports of air occurrences under the *Transportation Safety Board Regulations* (TSB Regulations) in 2023 (182 accidents and 838 incidents), including 33 fatalities (Figure 3).

Figure 3. Air transportation accidents, incidents, and fatalities, 2019 to 2023

The 2023 total of 182 reported accidents is a 10% increase over the previous year's total of 166 accidents and 17% below the yearly average of 220 accidents reported in the prior 10 years (2013–2022). Most of the accidents in 2023 (169) took place in Canada and involved Canadian-registered aircraft. In general, the number of air transportation accidents has decreased in the last decade.

Of the 182 accidents, 19 were fatal accidents with a total of 33 fatalities. This represents a slight reduction from the 24 fatal accidents with 34 fatalities in 2022 and is 24% below the average of 25 fatal accidents involving 40 fatalities over the ten-year average (2013–2022). Thirteen of the 33 air transportation fatalities in 2023 involved commercial operations: four of them under air taxi regulations (*Canadian Aviation Regulations* [CARs] 703), four under aerial work (CARs 702), and five under flight training operations (CARs 406). There were no fatalities involving airline operations (CARs 705) or commuter operations (CARs 704) in 2023. The remaining 20 (of 33) fatalities in 2023 were linked to privately registered aircraft and involved recreational operators.

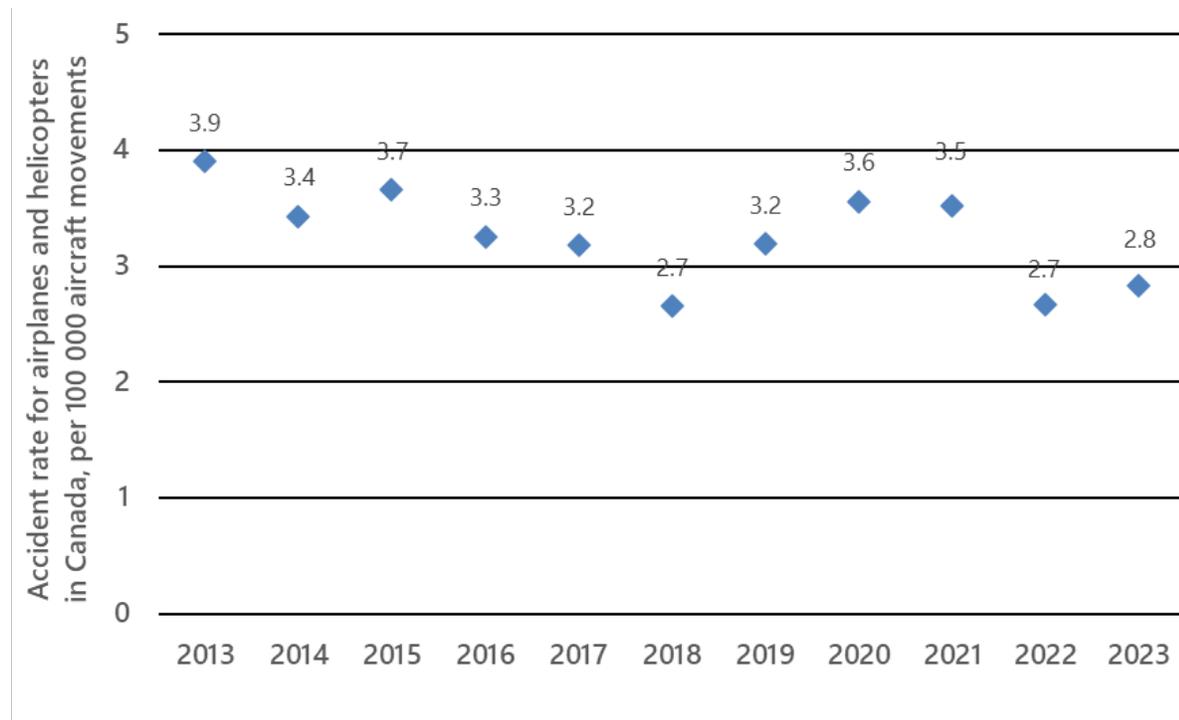
The overall air transportation accident rate of 2.8 accidents per 100 000 aircraft movements in 2023 is based on 156 accidents in Canada involving Canadian- and foreign-registered airplanes and helicopters (excluding ultralights, gyroplanes, gliders, and unmanned air vehicles) and the estimated 5.502 million movements at Canadian airports. The accident rate decreased from 3.9 accidents per 100 000 aircraft movements in 2013 to a low of 2.7 in both 2018 and 2022 before rising slightly again in 2023. While the decrease in this period is not statistically significant, the accident rate is among the lowest recorded by the TSB since it began measuring an accident rate by movements in 2004 (Figure 4).

Figure 4. Accident rate for Canadian-registered airplanes and helicopters in Canada, per 100 000 aircraft movements, 2013 to 2023

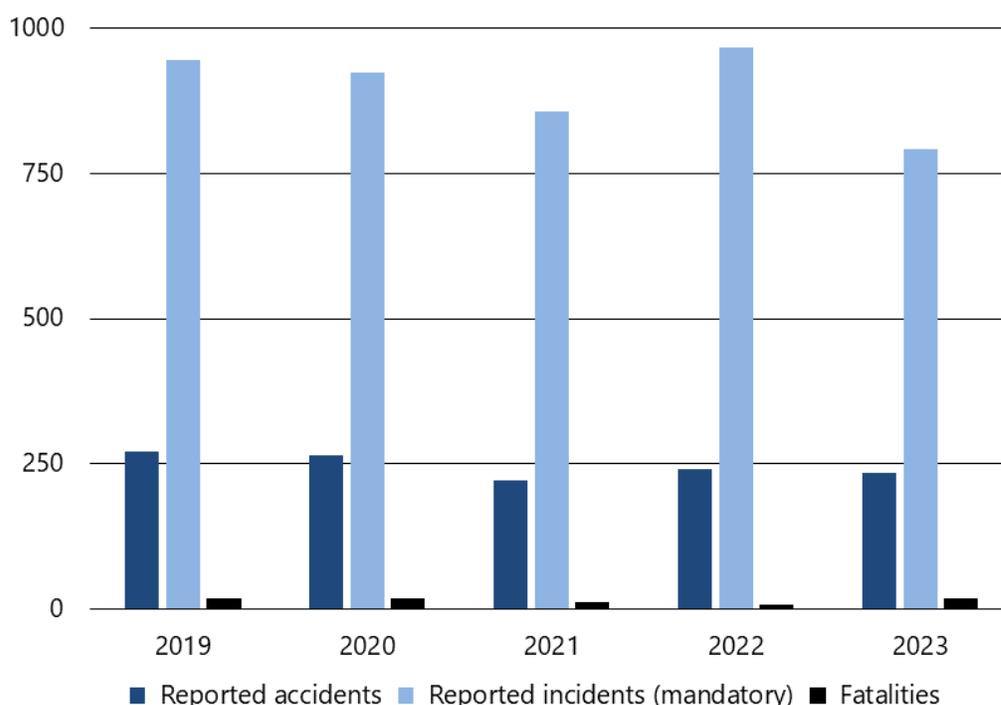
The Transportation Safety Board of Canada (TSB) received 1027 reports of marine transportation occurrences in 2023 (235 accidents and 792 incidents), including 18 fatalities.

Figure 5. Marine transportation accidents, incidents, and fatalities, 2019 to 2023

The 235 reported marine transportation accidents represent a decrease from the 244 accidents in 2022 and are below the 10-year average of 274. In 2023, 84% of accidents were shipping accidents (e.g., when a ship sinks, founders, or capsizes), slightly more than 82% on average over the previous 10 years. The remaining 16% of accidents in 2023 were accidents aboard a ship (e.g., when a person is killed or seriously injured when boarding a ship or by falling overboard), just below the 10-year annual average of 18%.

The 18 marine transportation fatalities are more than the 2022 total of seven and the 10-year average of 14. Of the 18 fatalities, 10 involved shipping accidents. Over the previous 10 years, fatalities have been evenly divided between shipping accidents and accidents aboard a ship.

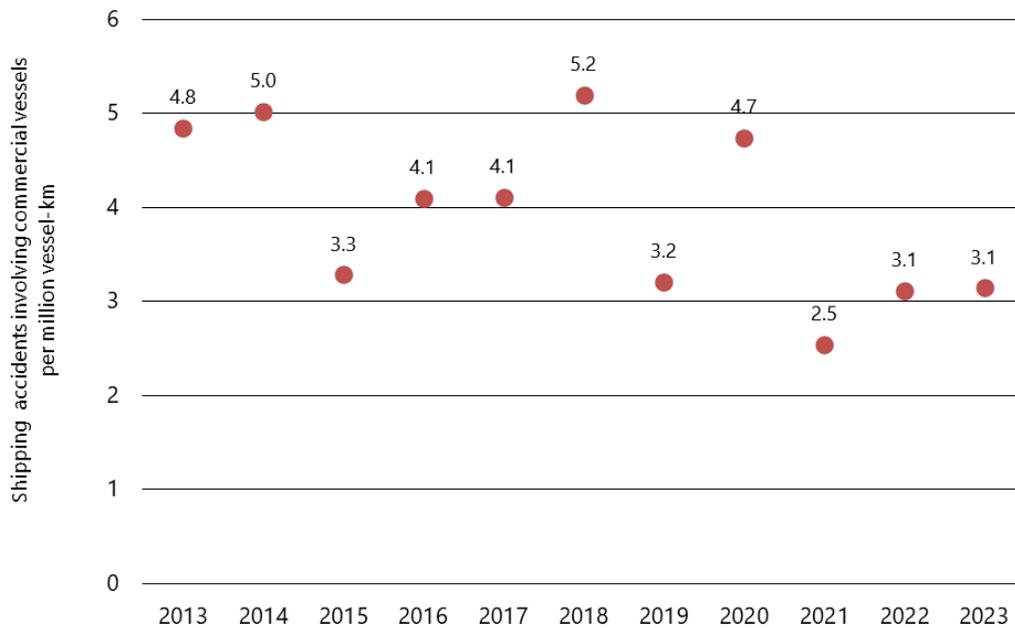
According to Transport Canada (TC), 2023 marine activity (i.e., commercial vessel kilometres) for Canadian commercial non-fishing vessels with a gross tonnage of over 15, excluding passenger vessels and cruise ships, was 12% above the 2013-22 average. The 2023 accident rate was 3.1 accidents per million commercial vessel-kilometres, lower than the 2013-22 average of 4.0.

Figure 6. Shipping accident rate, Canadian commercial non-fishing vessels, 2013 to 2023

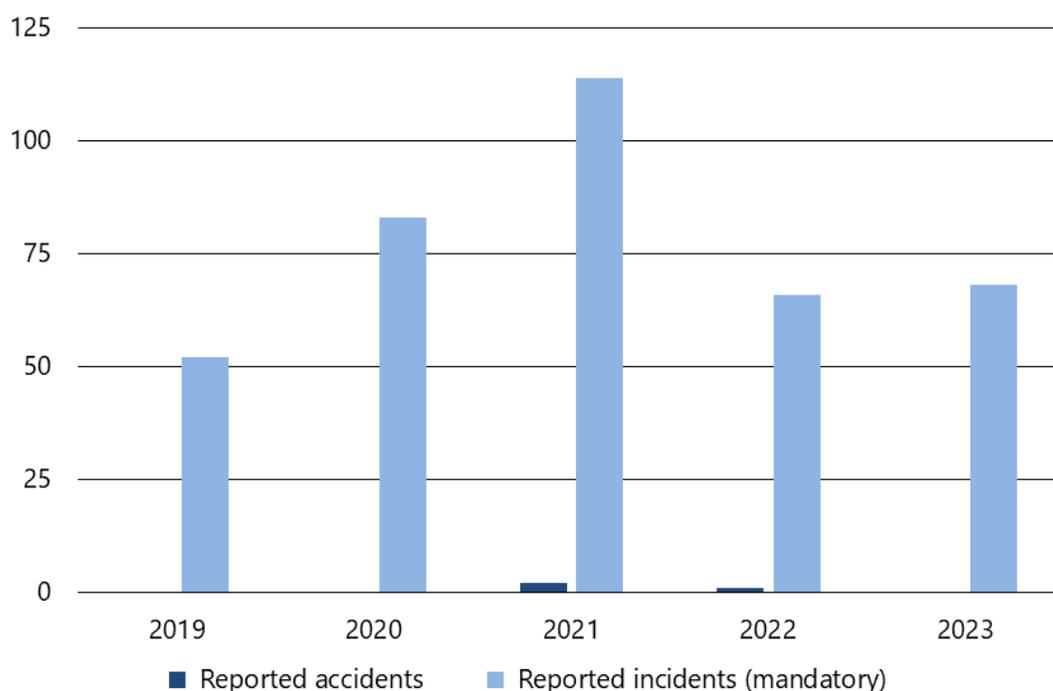
The Transportation Safety Board of Canada (TSB) received 68 reports of pipeline transportation occurrences in 2023, all of which were incidents. There were no pipeline accidents in 2023. There were no fatalities arising directly from the operation of any federally regulated pipeline, as has been the case since the TSB's inception in 1990.

Figure 7. Pipeline transportation accidents and incidents, 2019 to 2023

This number of occurrences in 2023 (68) is unchanged from 2022 and 33% below the average of 101 for the previous 10 years. While there were no pipeline accidents in 2023, the average number of accidents in the prior 10 years was two per year.

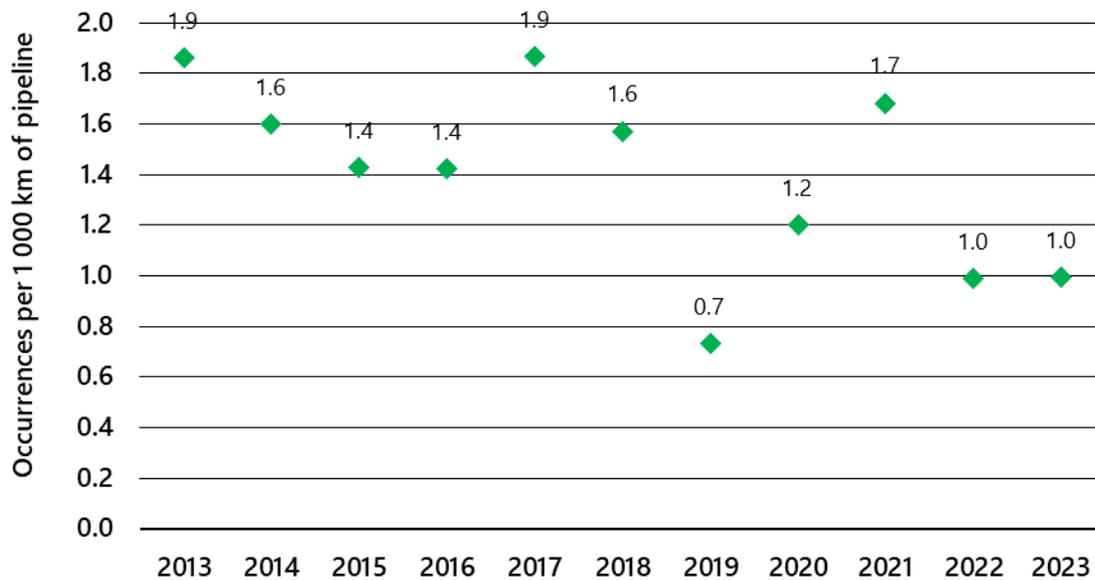
There were 68 200 km of federally regulated pipeline operating in Canada in 2023, according to the Canada Energy Regulator. The 68 pipeline transportation occurrences reported to the TSB for the year resulted in an occurrence rate per 1000 km of operating pipeline of 1.0. This is the same as the 2022 rate of 1.0 and below the average of 1.4 occurrences per 1000 km from 2013 to 2022.

Figure 8. Pipeline transportation occurrence rate, 2013 to 2023

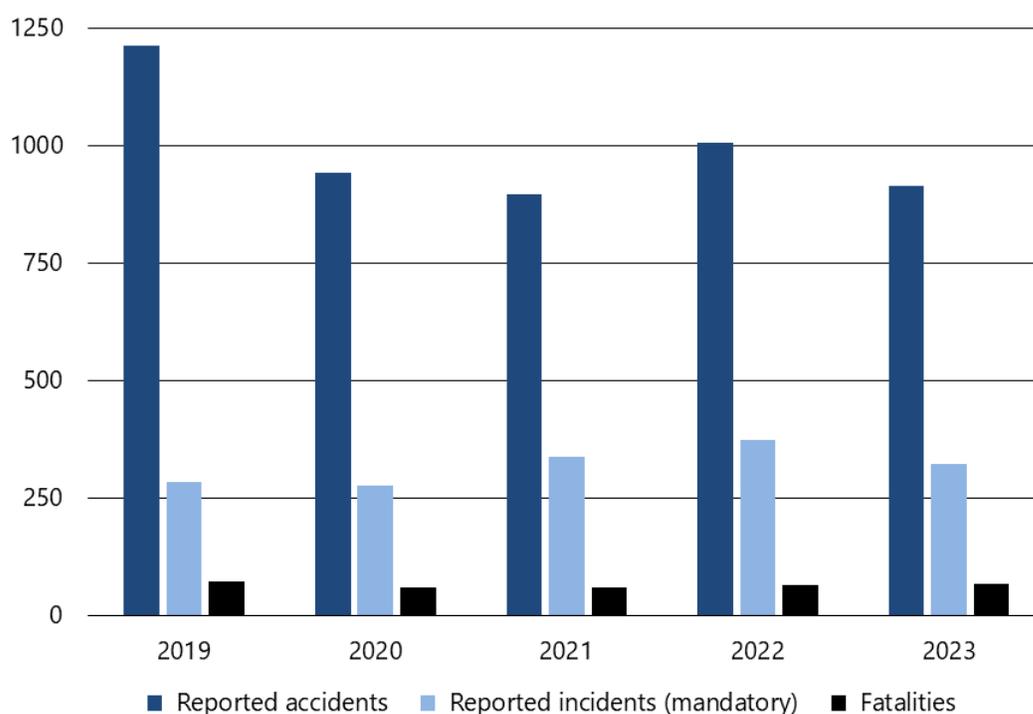
The Transportation Safety Board of Canada (TSB) received 1235 reports of rail transportation occurrences in 2023 (914 accidents and 321 incidents), including 67 fatalities.

Figure 9. Rail transportation accidents, incidents, and fatalities, 2019 to 2023

The 914 reported accidents represent a 9% decrease from 2022 and a 12% decrease from the 10-year average of 1039.

The 67 reported fatalities in rail transportation represents a slight increase compared to the 65 reported fatalities in 2022 but remains below the 10-year average of 68. Among these fatalities, 53 involved trespassers, compared to 51 in 2022 and the 10-year average of 41.

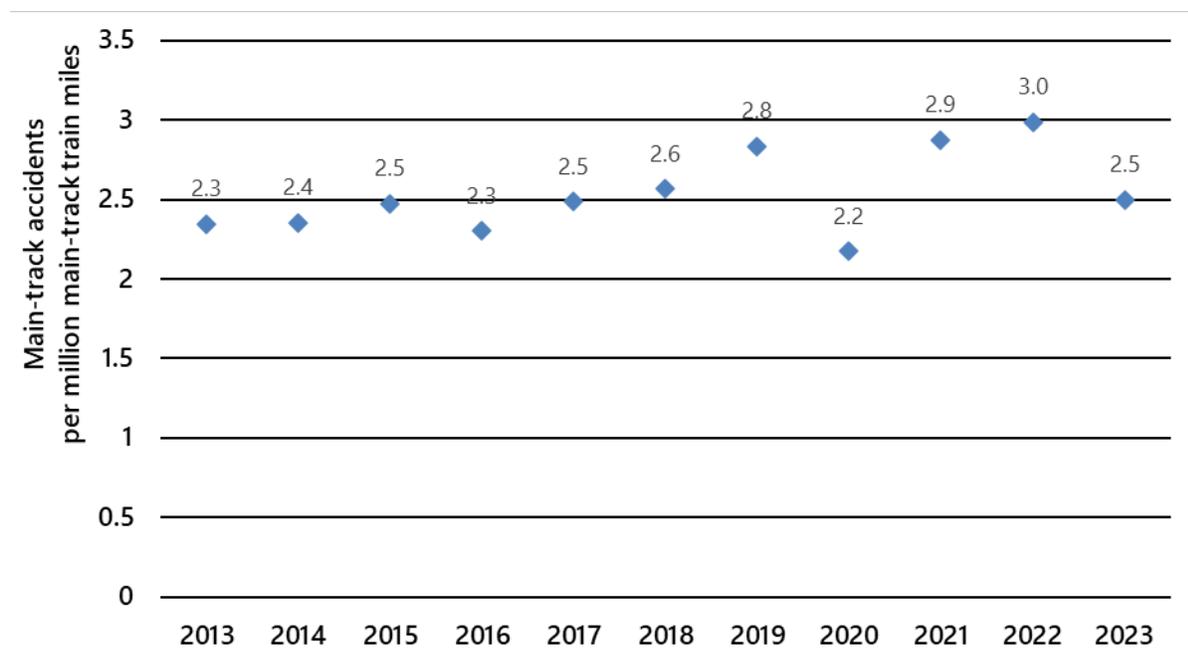
According to Transport Canada (TC) data, 2023 main-track rail activity (i.e., non-yard) increased by 4% from 2022. The main-track accident rate in 2023 was 2.5 accidents per million main-track train-miles, a decrease from 3.0 in 2022 and below the 10-year average of 2.6.

Figure 10. Main-track accident rate, 2013 to 2023

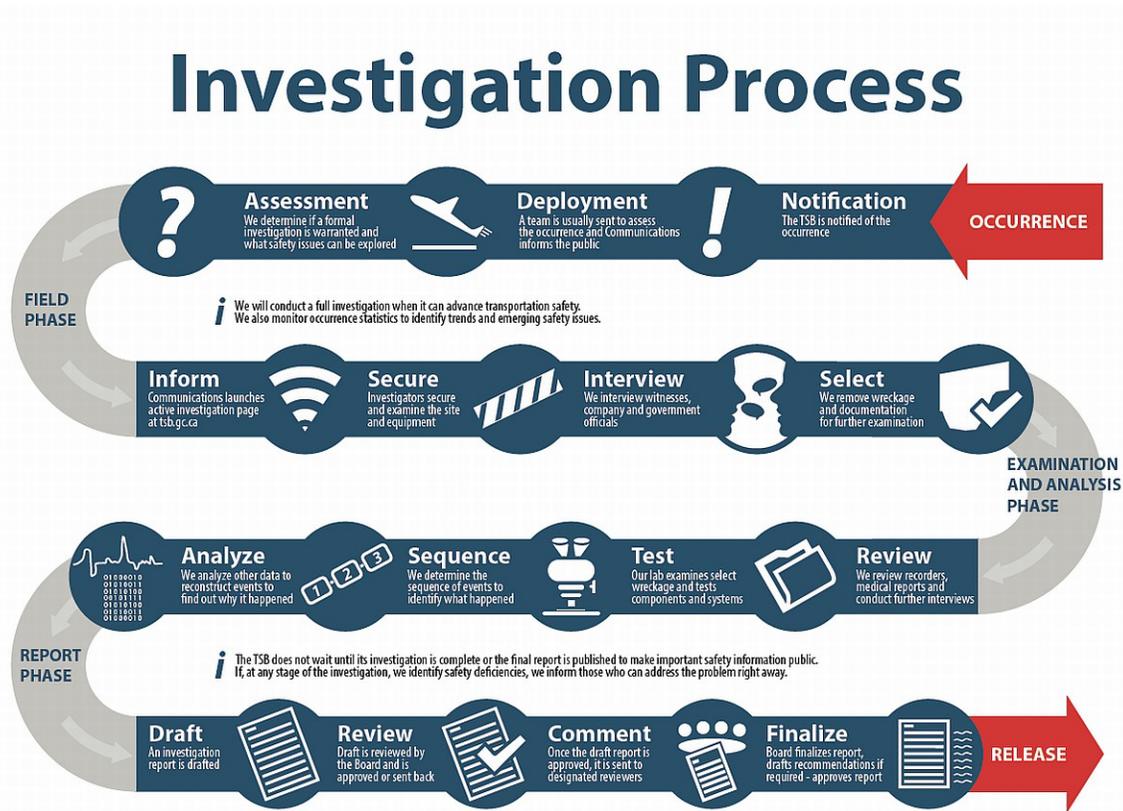
In the report phase, investigators draft a report on the investigation, which then goes through a review and approval process, prior to public release.

Figure 11. The TSB investigation process from occurrence to report

Once the Board approves the final report, it is released to the public on the TSB website and through traditional and social media.
